CASE REPORT

Dr. Bianca Baican, MD Plastische Chirurgie Frankfurt, Hochtaunus

Sentinel Lymph Node (SLN) Biopsy

in a Breast Cancer Patient using Indocyanine Green (ICG) with the IC Flow[™] Imaging System

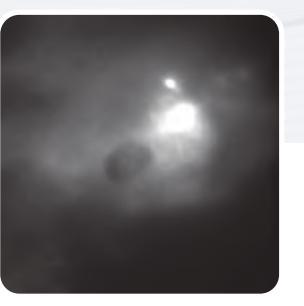
Figure 2. Fluorescence following ICG injection.

The day before surgery, the patient was injected with the radionuclide agent Technetium (Tc99m). Immediately prior to surgery, a 25 mg vial of ICG was prepared with 5 ml of sterile water. Once the patient was anaesthetized, and prior to skin preparation, ICG (2ml) was injected intra-dermally to the perioareolar quadrant, where the tumor was located (Figure 1 & Figure 2).

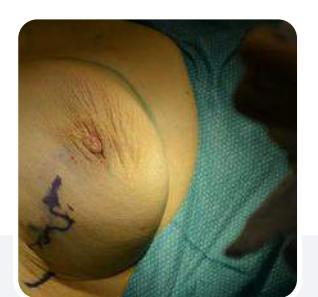
Figure 3. Fluorescence begins to spread.

Holding the IC-Flow[™] Imaging System above the injected tissue, lymphatic vessels containing ICG are visible transcutaneously (up to a depth of 2 cm) and can be mapped to the axilla. This combination of ICG fluorescence and the IC-Flow[™] Imaging System facilitated the tracking of the breast lymphatics and allowed the user to visualize in real-time the flow of lymph through the vessels (Figure 3). Additionally, mapping of the fluorescent lymphatic vessels helps to identify the approximate location of the SLNs in the axillary region (Figure 4).

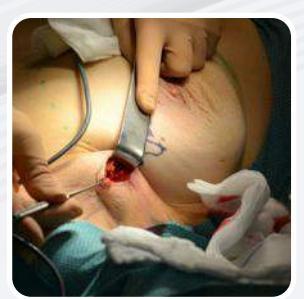
Figure 5. Incision of axilla.

After the axilla was incised (Figure 5), the tissue was dissected until the axillary fascia was reached and opened. Using the camera, the axilla was examined for tissue fluorescence (Figure 6). A fluorescent SLN was identified (Figure 7), and confirmed by both palpation and the gamma probe prior to its removal. In this case, the SLN was easily detectable, as the fluorescent tissue was clearly visible. After the SLN excision, fluorescent lymphatic vessels remain visible in the axilla (Figure 8).

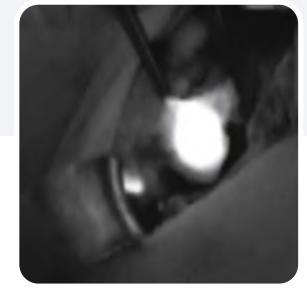
Figure 7. Fluorescent SLN identified.

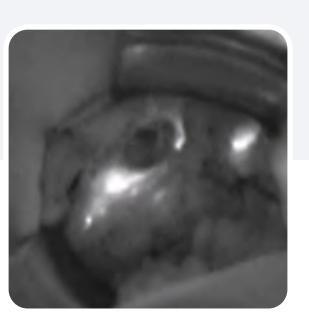
Figure 8. Axillary tissue post SLN excision.

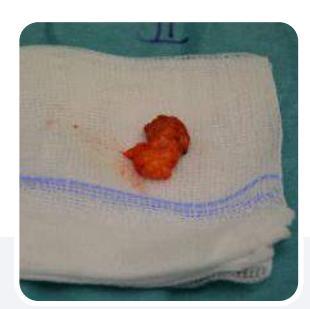
Figure 9. Excised SLN.

After removal the lymph nodes are examined once again using both the gamma probe and camera (Figures 9 & 10). Then, the lymph nodes are sent to the laboratory for further histological examination. Before closure, the camera is used to reexamine the axillary tissue to ensure that all ICG and Technetium labelled sentinel lymph nodes, have been excised.

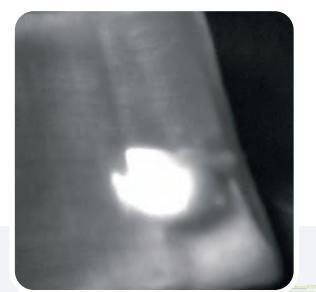
Figure 10. Excised fluorescent SLN.
